ESL-TR-85-65

RAPID RUNWAY REPAIR (RRR) IN-HOUSE TEST AND EVALUATION

FINAL REPORT

ENGINEERING & SERVICES LABORATORY
AIR FORCE ENGINEERING & SERVICES CENTER
TYNDALL AIR FORCE BASE, FLORIDA 32403

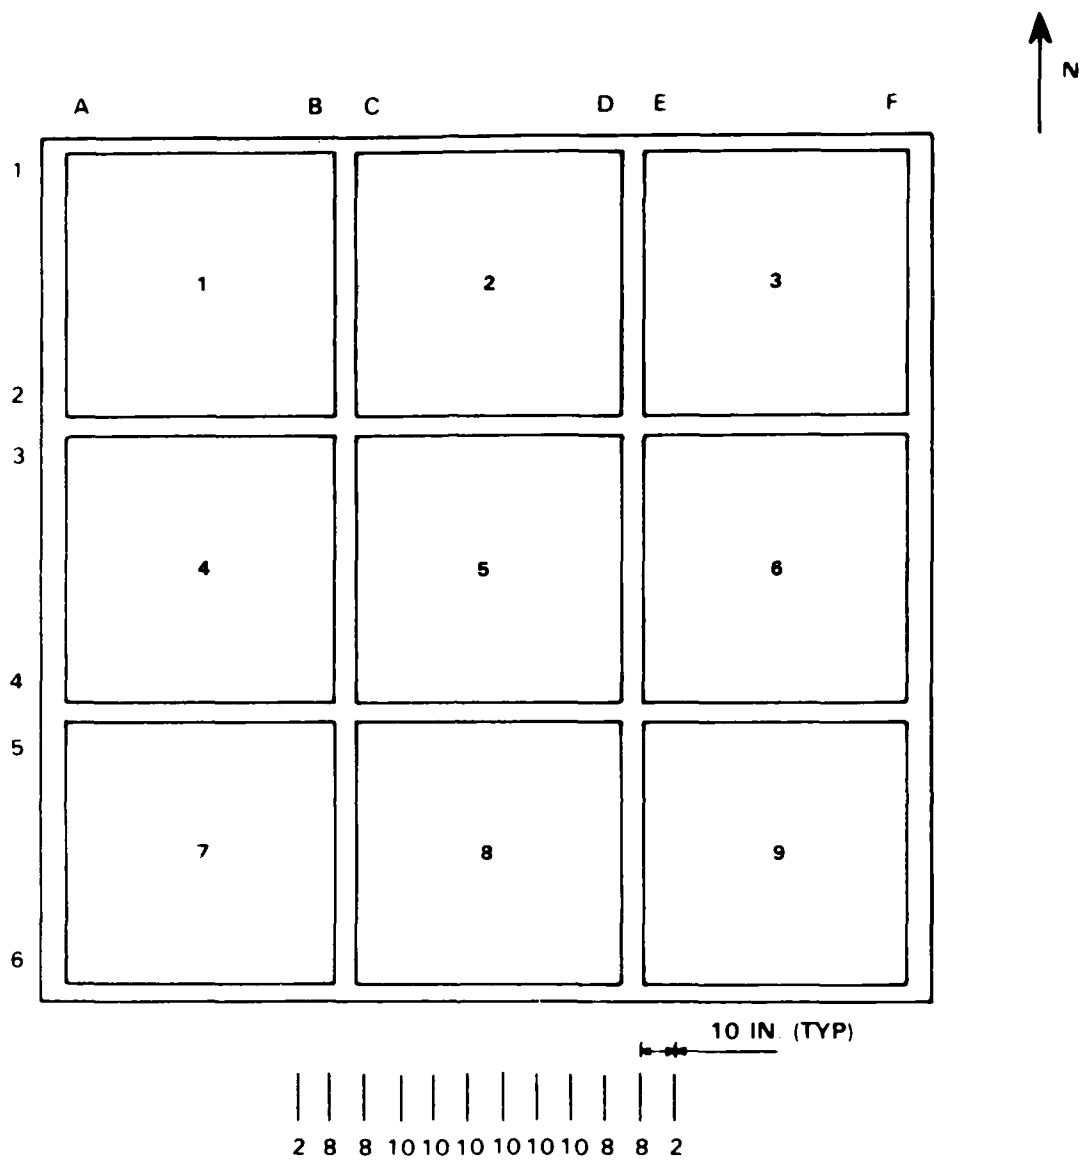
Figure 21. Traffic Pattern and Profile Lines for Preliminary Precast Slab Test.

Test observations cite pavement upheaval around the crater lip of up to 2 1/2 inches along the south edge of the repair (Figure 21) and approximately 1 inch along the north edge. When test personnel placed the concrete slabs on the pea gravel, the corners were flush with the upheaved pavement. Elevations of slab corners taken before leveling ranged from 0.5 to 1.625 inches on the north edge and from 1 to 3 inches along the south edge. Test personnel judged corners A-6 and F-6 to be too high prior to testing, so they removed Slabs 7 and 9, and releveled the slabs.

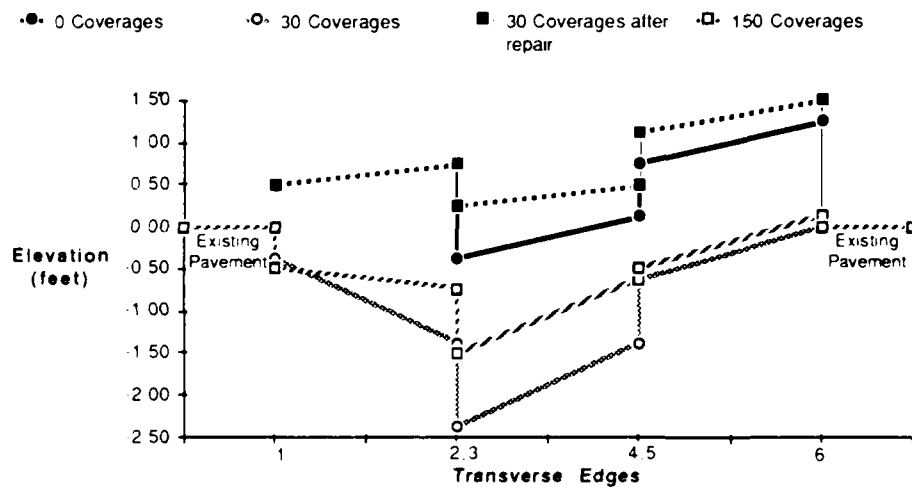
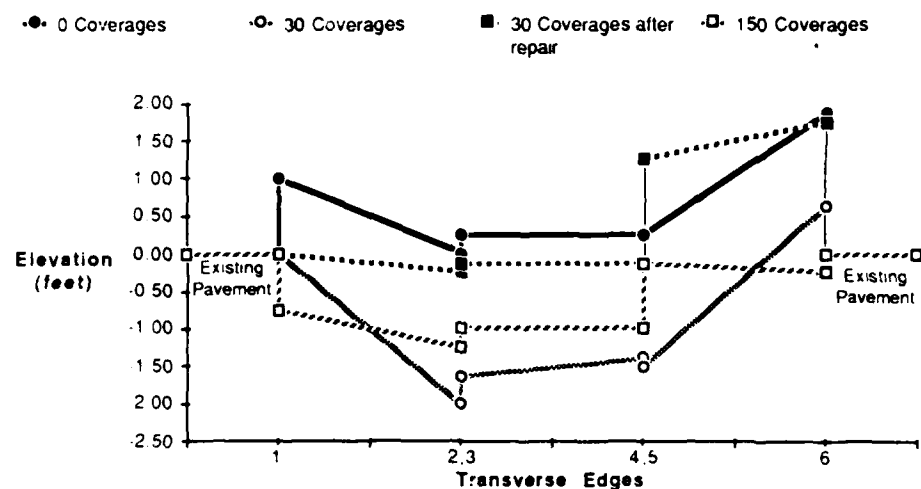
Figures 22 through 27 profile slab corners along longitudinal edges before traffic, after 30 coverages, after releveling, and after 150 coverages. The differential settlement that resulted is evident by the diverging plots of Slab 1 (Edge 1-2), as shown in Figures 22 and 23, and Slab 2, as shown in Figure 24 and 25. Except for the settlement during the first 30 passes, the two corners of Slab 4 (Edge 3-4) settled almost the same amount, as shown in Figures 22 and 23, both being in the center of the crater. However, Corner B 2 of Slab 1 toward the crater center settled $2 \frac{1}{8}$ inches, while corners supported by the denser original base course near the crater edge settled only $\frac{7}{8}$ inch. The edge along Line 6 of the current test section is near the middle of an earlier crater repair, which probably had more consistent debris backfill subgrade. Some of this earlier backfill was still in place for this test; therefore, Slab 7 and other slabs along the south side of the crater did not exhibit severe differential settlement.

Figure 23. Slab Elevation Profiles Along Longitudinal Edge B, Preliminary Test.

Figure 24. Slab Elevation Profiles Along Longitudinal Edge C, Preliminary Test.

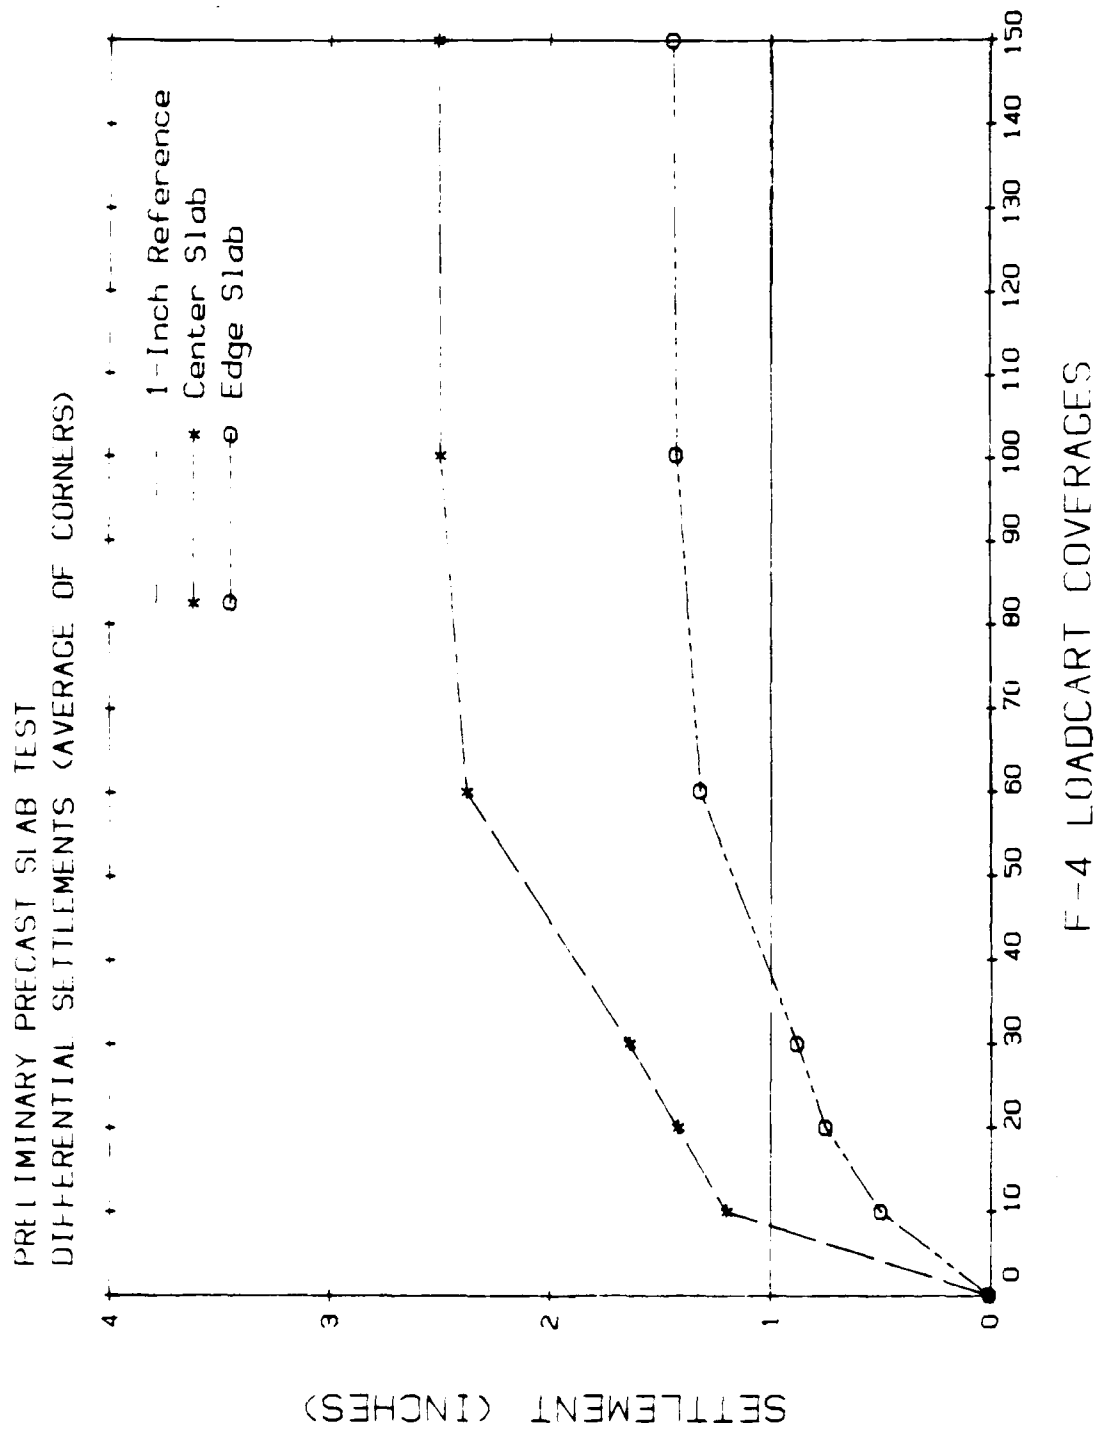
Figure 29. Settlement Versus F-4 Loadcard Coverages, Preliminary Test.

Test 1 tested precast slabs placed on 22 inches of pea gravel over 4 feet of compacted debris backfill to determine the severity of differential settlement of individual slabs in the repair center and of slabs near the edge under F-4 loadcart traffic. The differential settlement problem was confirmed and is shown in Figure 29, which plots settlement (average of the four slab corners settlement) versus traffic for Slab 4 along the crater edge and Slab 5 at the crater center.

fill, compacting more prior to traffic, and avoiding the use of large debris so as not to create subsurface voids. One method is to use ballast rock beginning at a minimum depth of 36 inches from the surface. Ballast rock may not require compaction to achieve dense condition, and will exhibit less particle-to-particle motion than pea gravel thereby also reducing differential settlement.

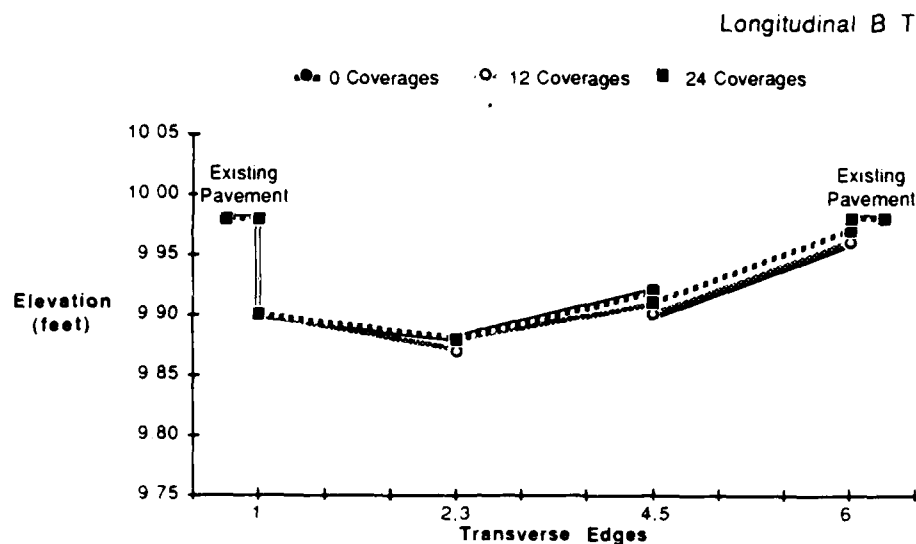
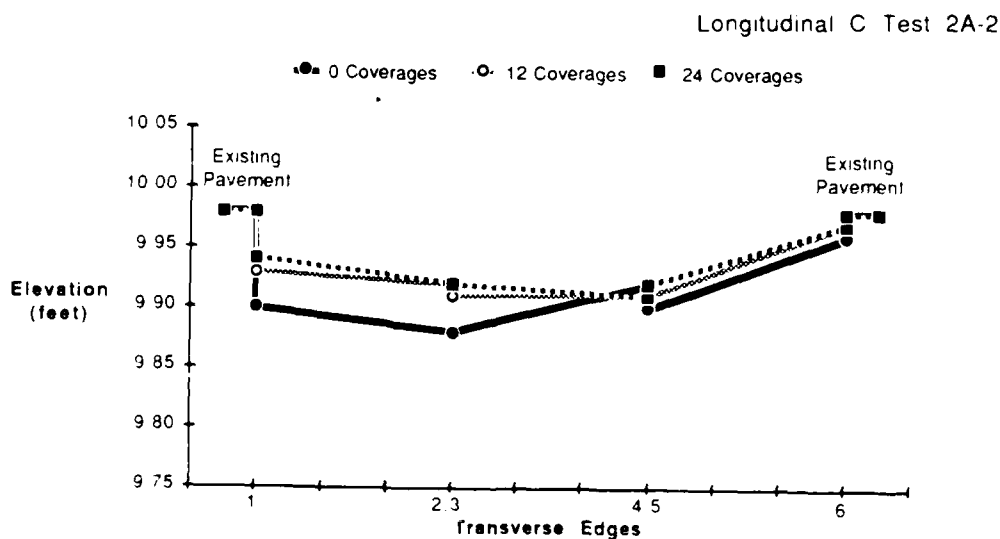
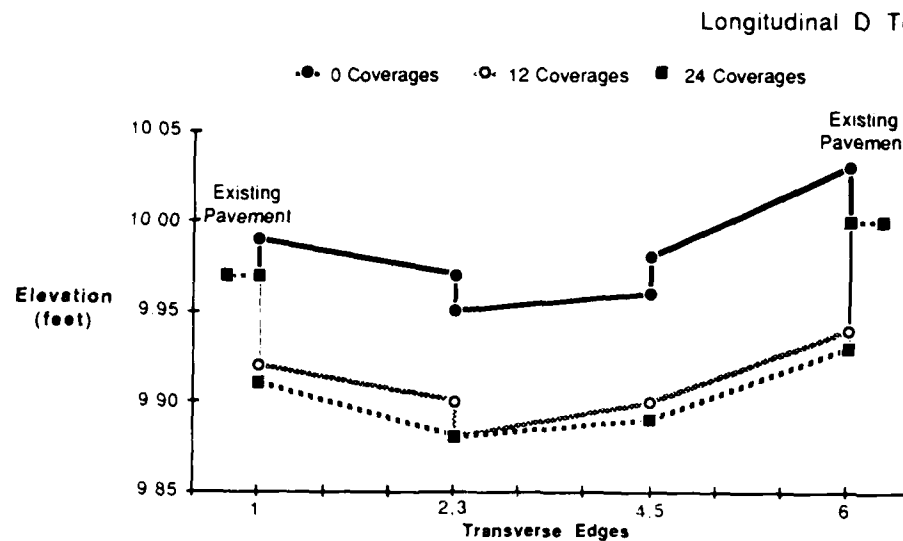
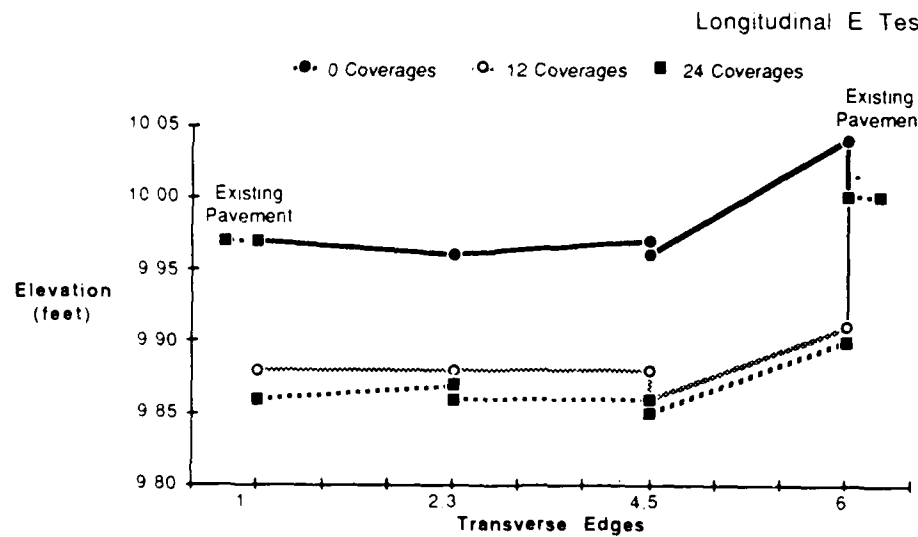
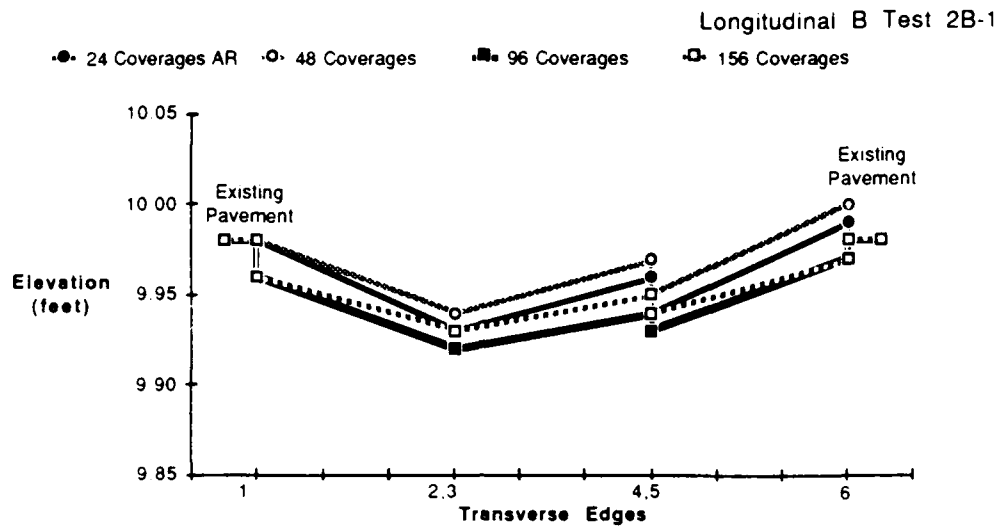
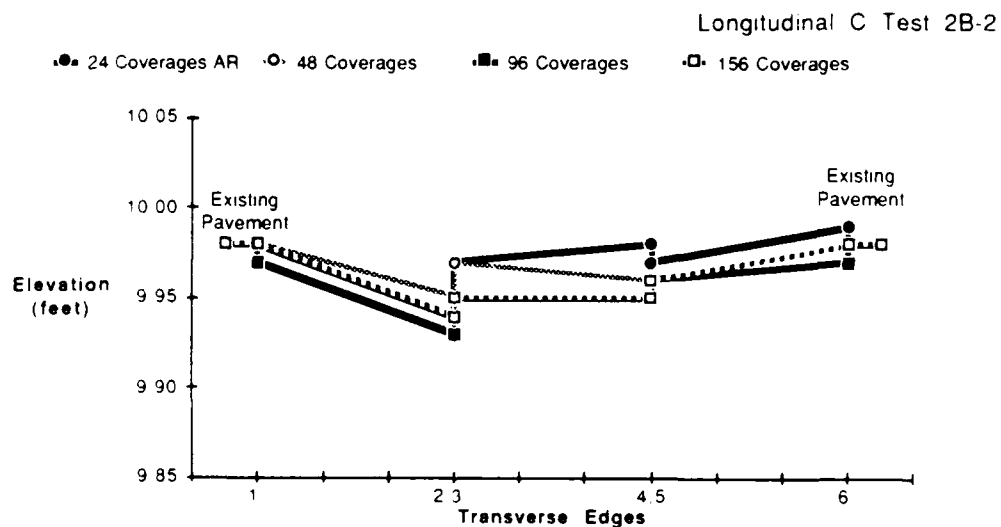
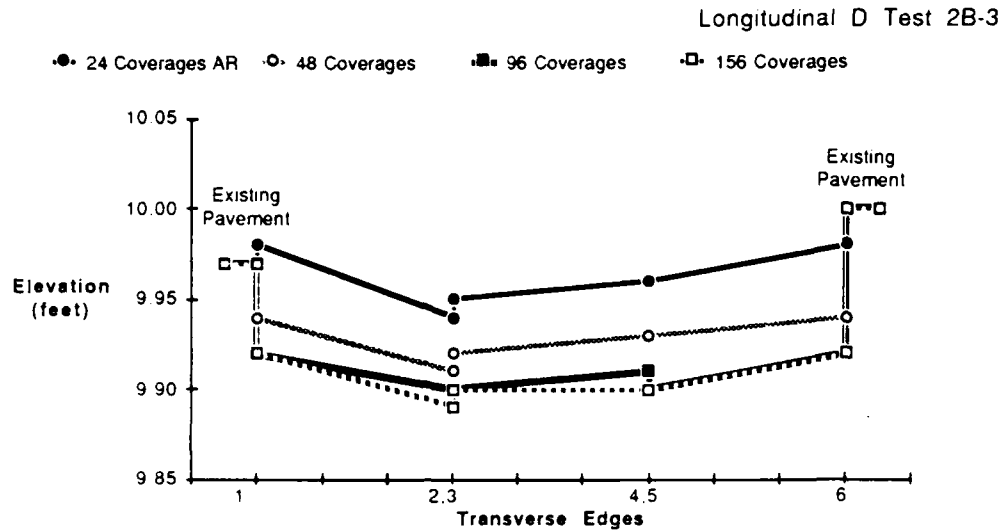
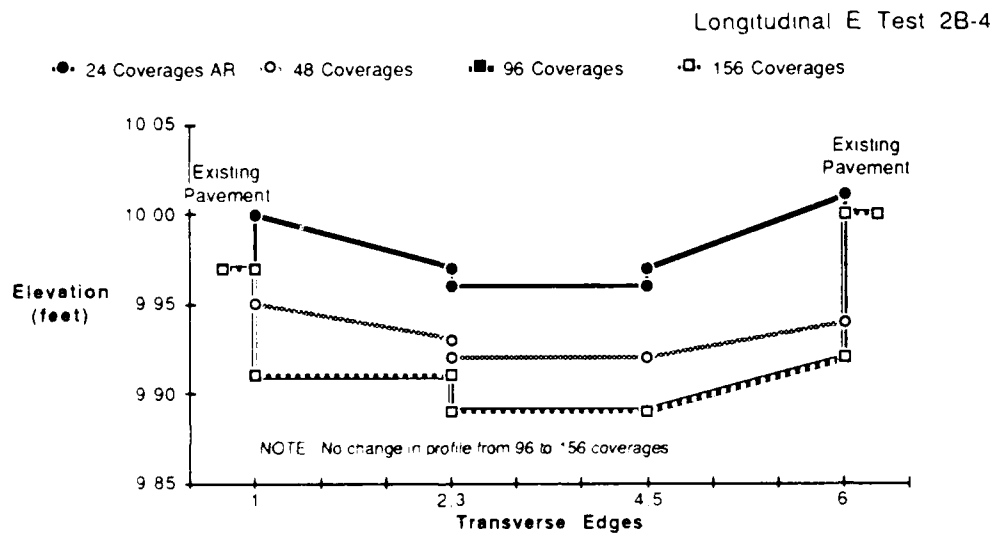
Figures 31 through 38 present elevation profiles of slabs along Edge B, C, D, and E during F-4 loadcart traffic. Only vertical measurements were taken during the surveys.

Throughout trafficking, the slabs shifted towards the center of the section and consistently rocked toward the traffic lane. As previously mentioned, filler sand settled below the slabs by the time 12 loadcart coverages were applied due to the rocking and shifting of the slabs.

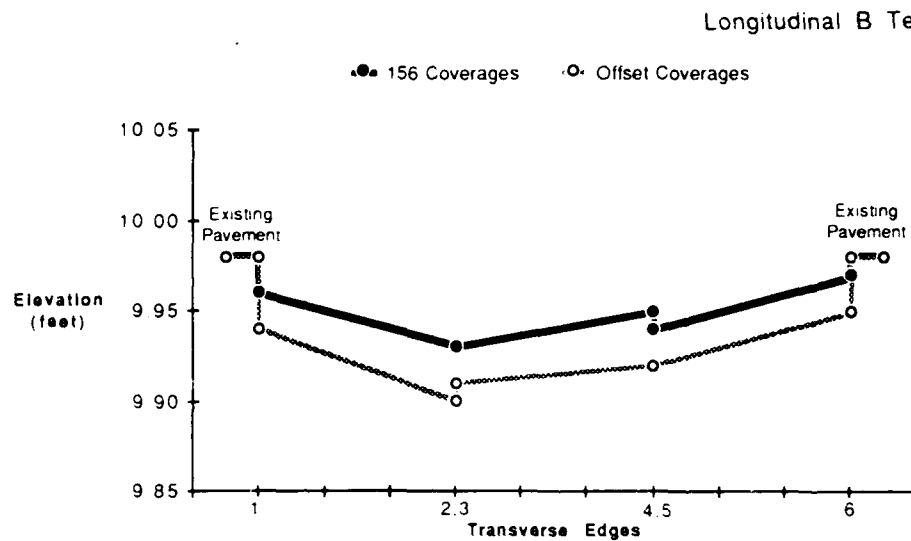
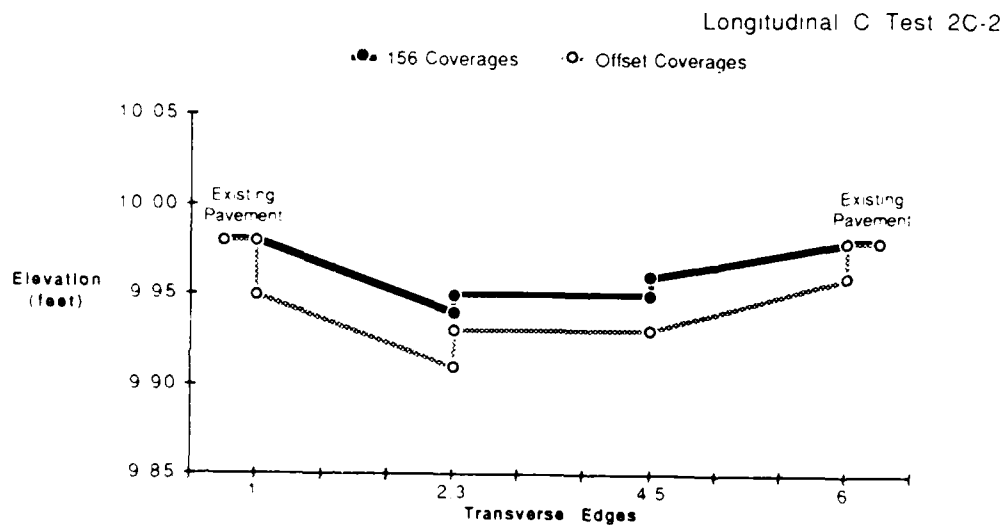
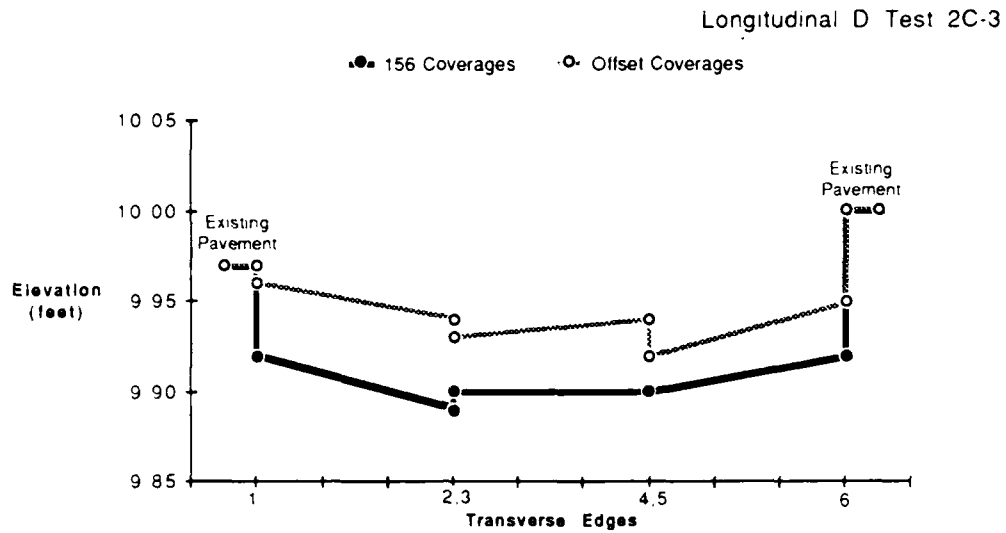
The loadcart applied an additional 12 coverages (shown as 157-168 coverages on Figure 30) which were applied to the section over Slabs 7, 8, and 9. Figures 39 to 42 present elevation profiles before and after the additional 12 passes. Relative settlement of adjacent slabs from the additional traffic was less than 1 inch in all locations.

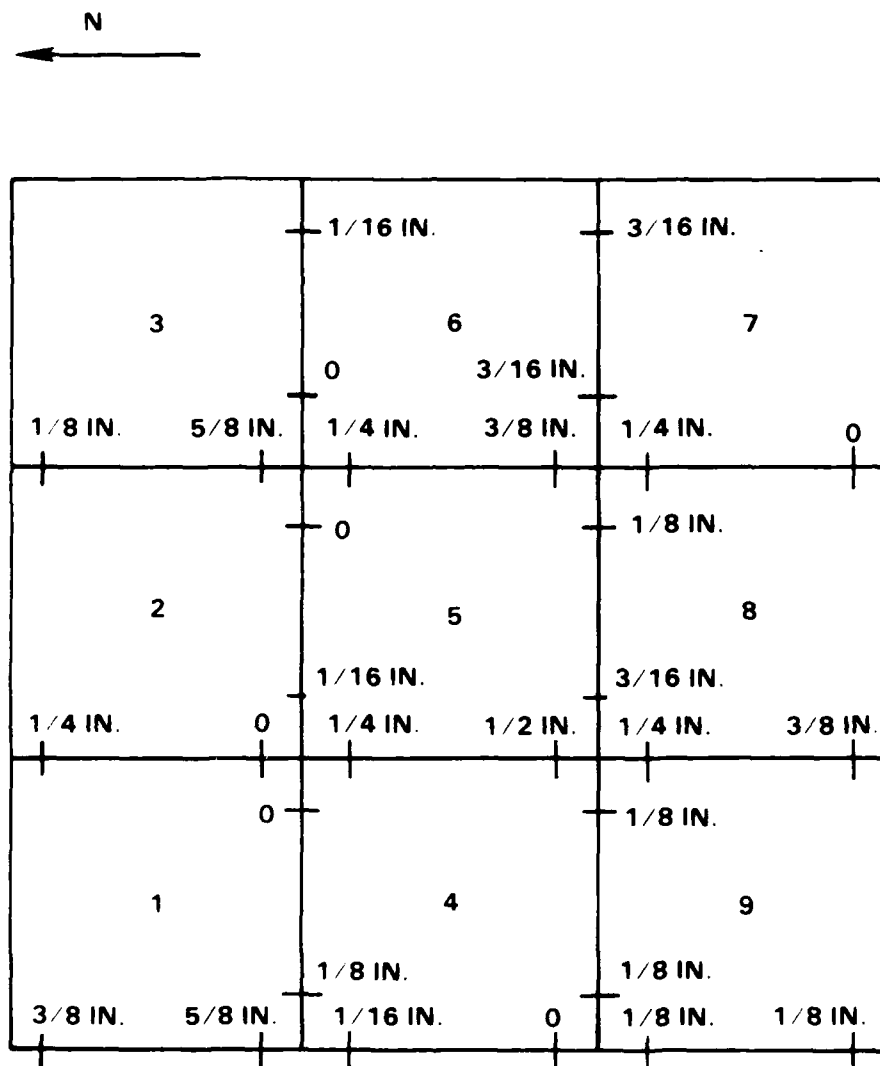
After 48 loadcart coverages, data collectors noted slight shifting of the slabs. The shifting caused complete closing of several joints while others expanded up to 5/8 inch (Figure 83). Personnel observed no significant difference in slab shifting between the sand-filled joint areas and the unfilled joint areas, and the sand filler appeared to have little effect on slab settlement as both halves of the test section settled approximately the same amount. The average slab corner settlement in the joint-filled half of the section was 0.61 inches while the average settlement in the open joint half of the section was 0.70 inches.

Figure 83. Joint Spacing after 48 F-4 Loadcart F-4 Loadcart Coverages Test 5.

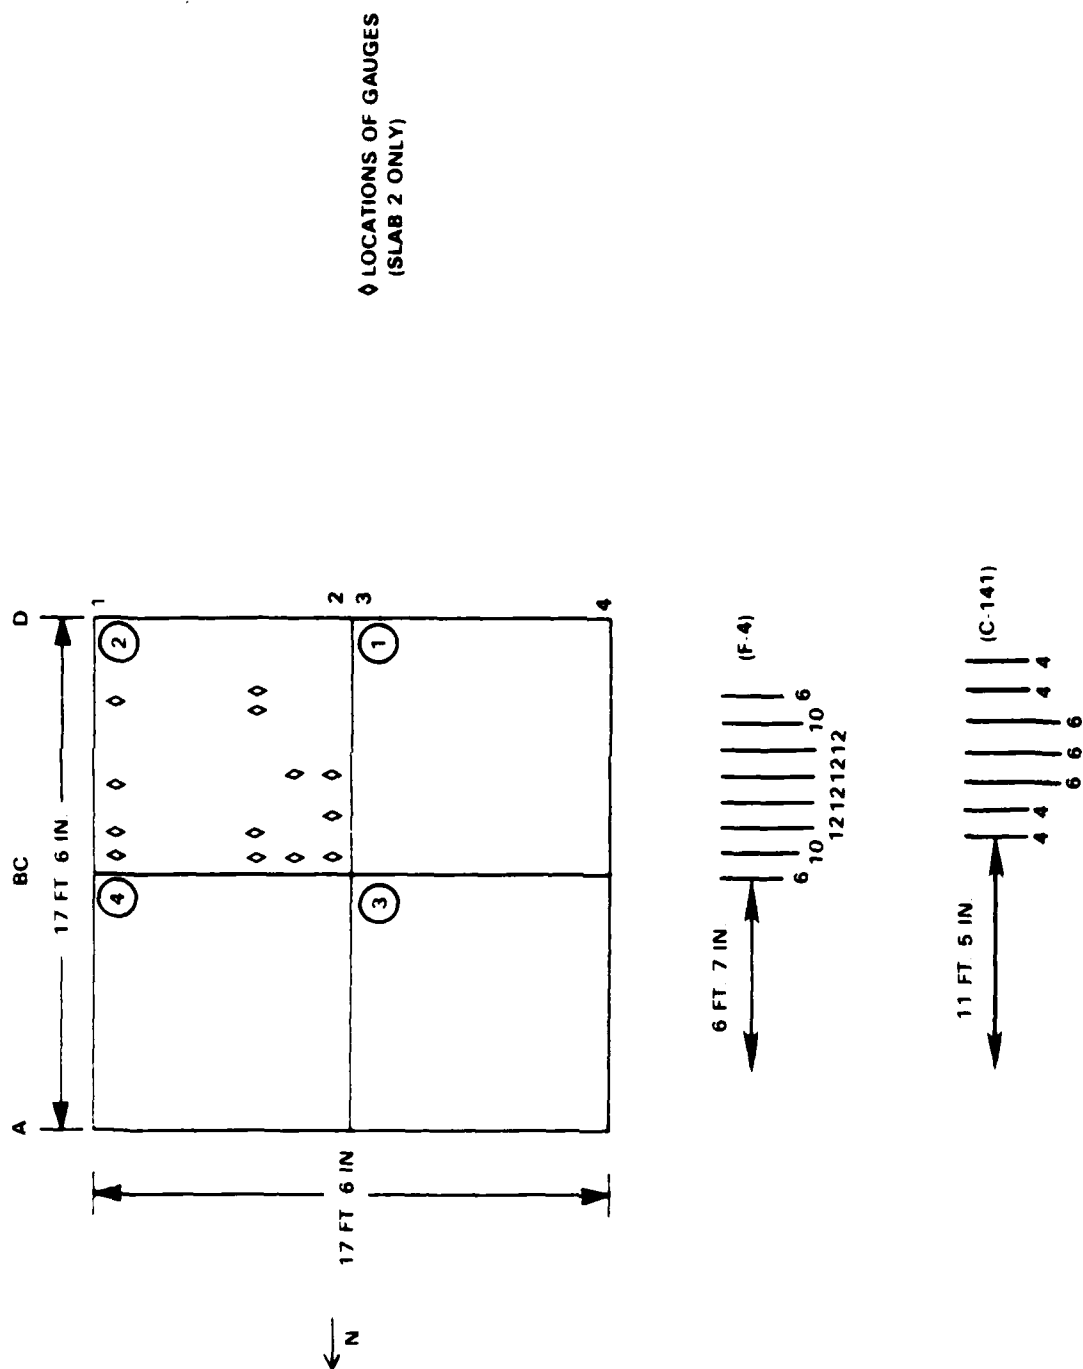
Figure 84. Plan of Test Section, Test 6: 3-Meter Slabs (Uncompacted Ballast Rock Fill over Number 57 Leveling Course).

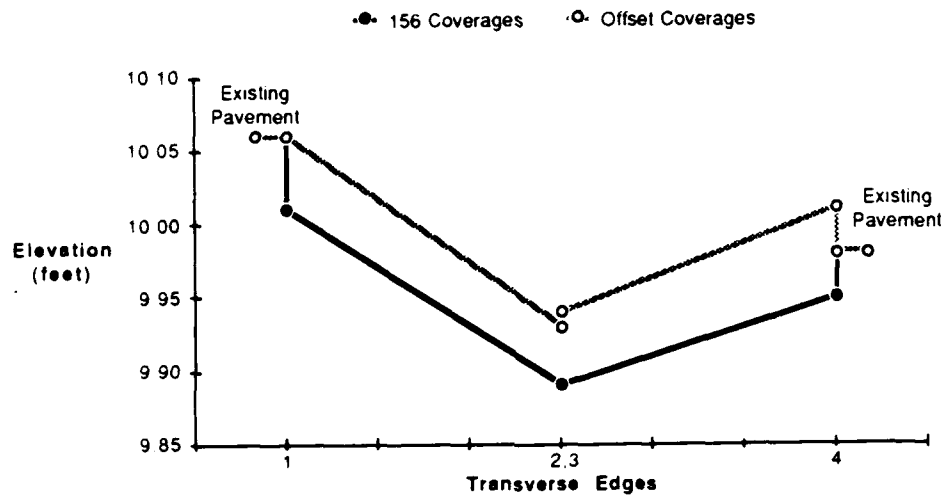
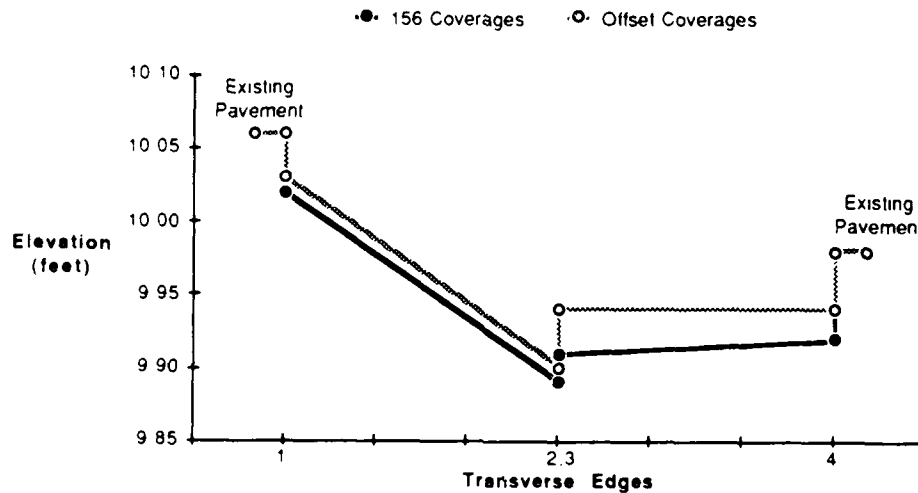
After the scheduled 156 F-4 loadcart coverages were applied, personnel applied an additional 60 coverages to Slabs 1 and 2, according to the distribution pattern in Figure 84, to lower the north half (Line C) of Slab 1 and 2 and reduce the rocking of the individual slabs. Elevation measurements before and after application of the additional coverages show that rocking of both slabs was reduced during the traffic (Figures 87 and 88).

Figure 37. Slab Elevation Profiles Along longitudinal Edge B, Test 6: 3-Meter Slabs - Uncompacted Ballast Rock Fill with Number 57 Leveling Course (Before and after Offset F-4 Loadcart Coverages).

Figure 38. Slab Elevation Profiles Along longitudinal Edge C, Test 6: 3-Meter Slabs - Uncompacted Ballast Rock Fill with Number 57 Leveling Course (Before and after Offset F-4 Loadcart Coverages).

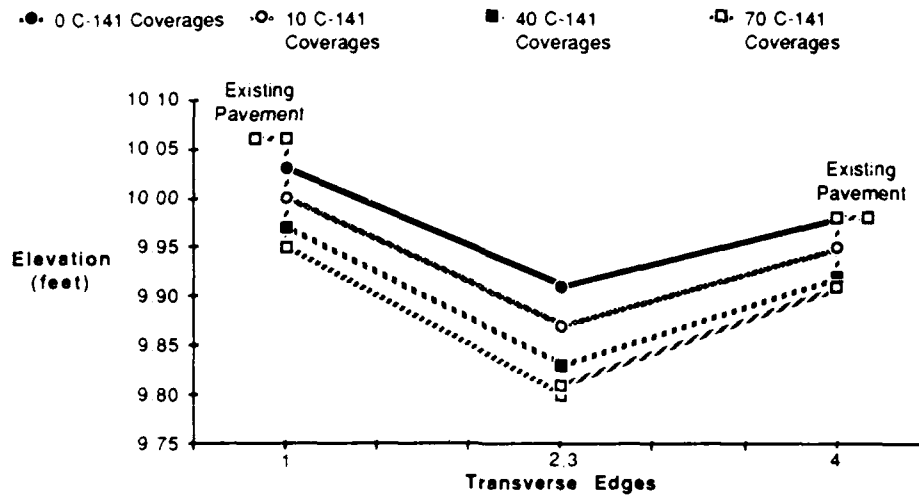
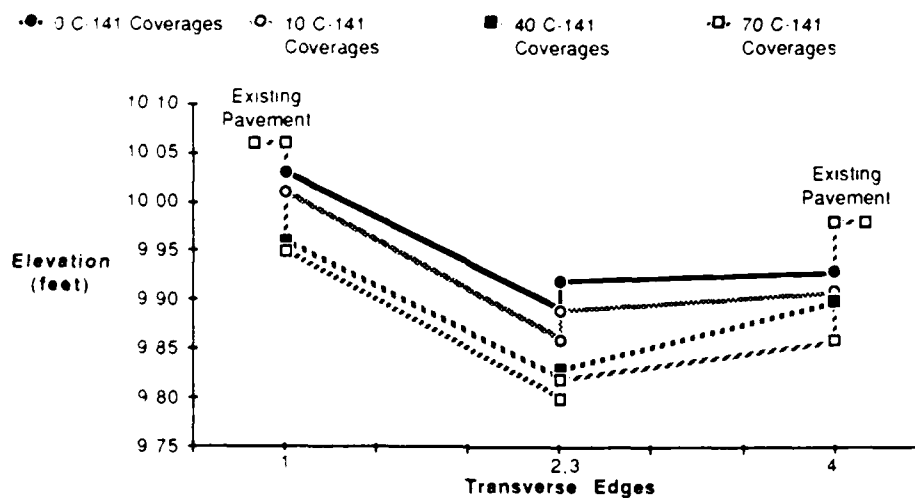
Following the application of the additional F-4 traffic, personnel interrupted the test to conduct the dynamic load testing (Test 7). They applied the C-141 loadcart traffic scheduled for Test 6 after the dynamic load testing. Figures 89 and 90 present slab elevations at the beginning of C-141 traffic and after 10, 40, and 70 coverages. Significant settlement, exceeding 2 inches in Slab 4, occurred along the central longitudinal joint. Despite the excessive settlement, personnel conducted no maintenance but continued traffic until 70 coverages had been applied.

Figure 89. Slab Elevation Profiles Along Longitudinal Edge B, Test 6: 3-Meter Slabs - Uncompacted Ballast Rock Fill with Number 57 Leveling Course (0, 10, 40, and 70 C-141 Loadcart Coverages).

Figure 90. Slab Elevation Profiles Along Longitudinal Edge C, Test 6: 3-Meter Slabs - Uncompacted Ballast Rock Fill with Number 57 Leveling Course (0, 10, 40, and 70 C-141 Loadcart Coverages).

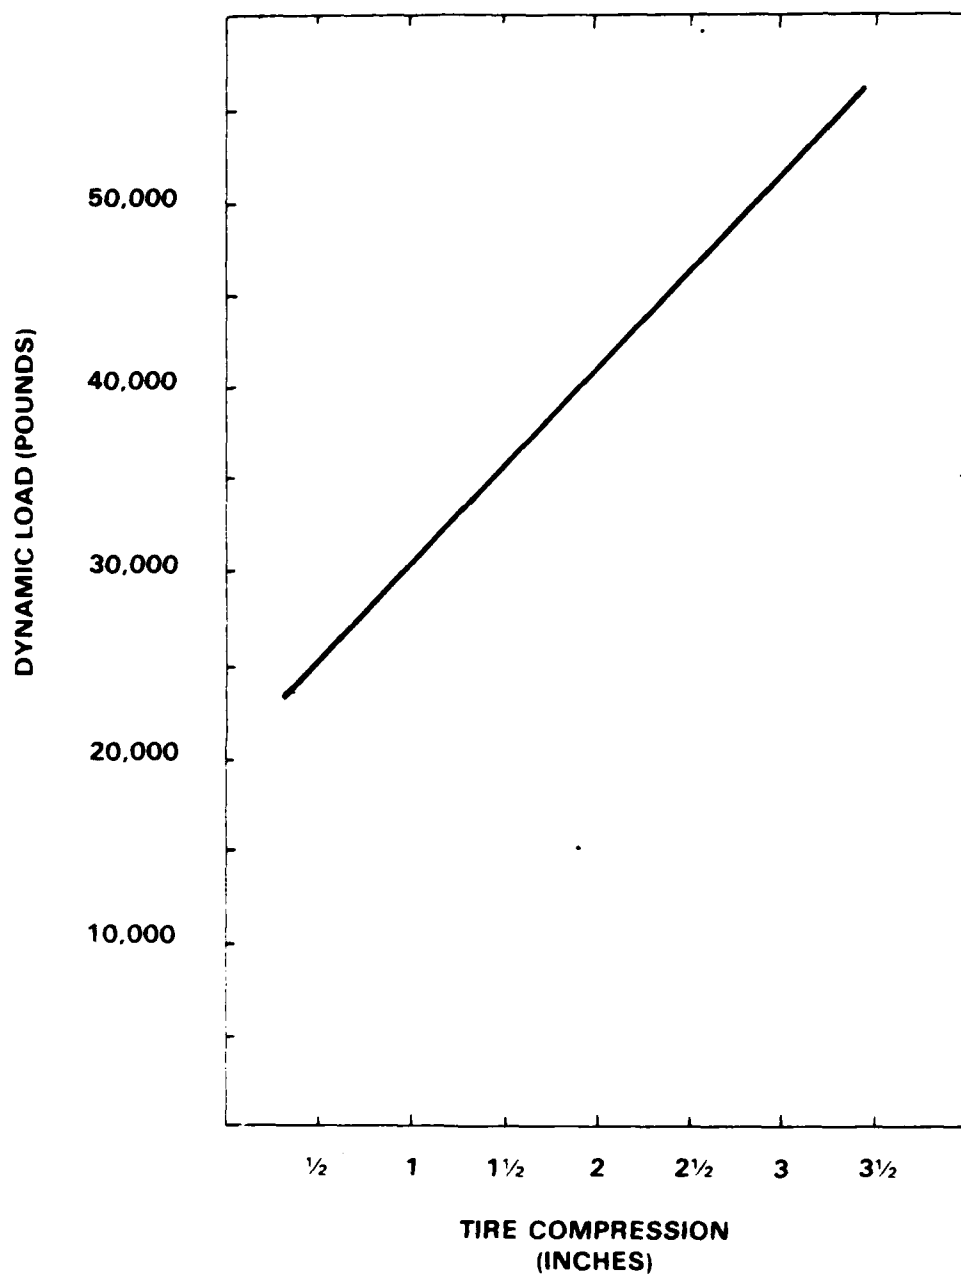
AFESC personnel conducted the test as planned. Table 5 presents the tire compression and the corresponding dynamic load for each test. AFESC personnel determined the relationship between the tire compression and load was linear, as plotted in Figure 93. Data collectors reported no damage for any slab in either test pit.

Figure 93. Tire Compression Versus Dynamic Load.

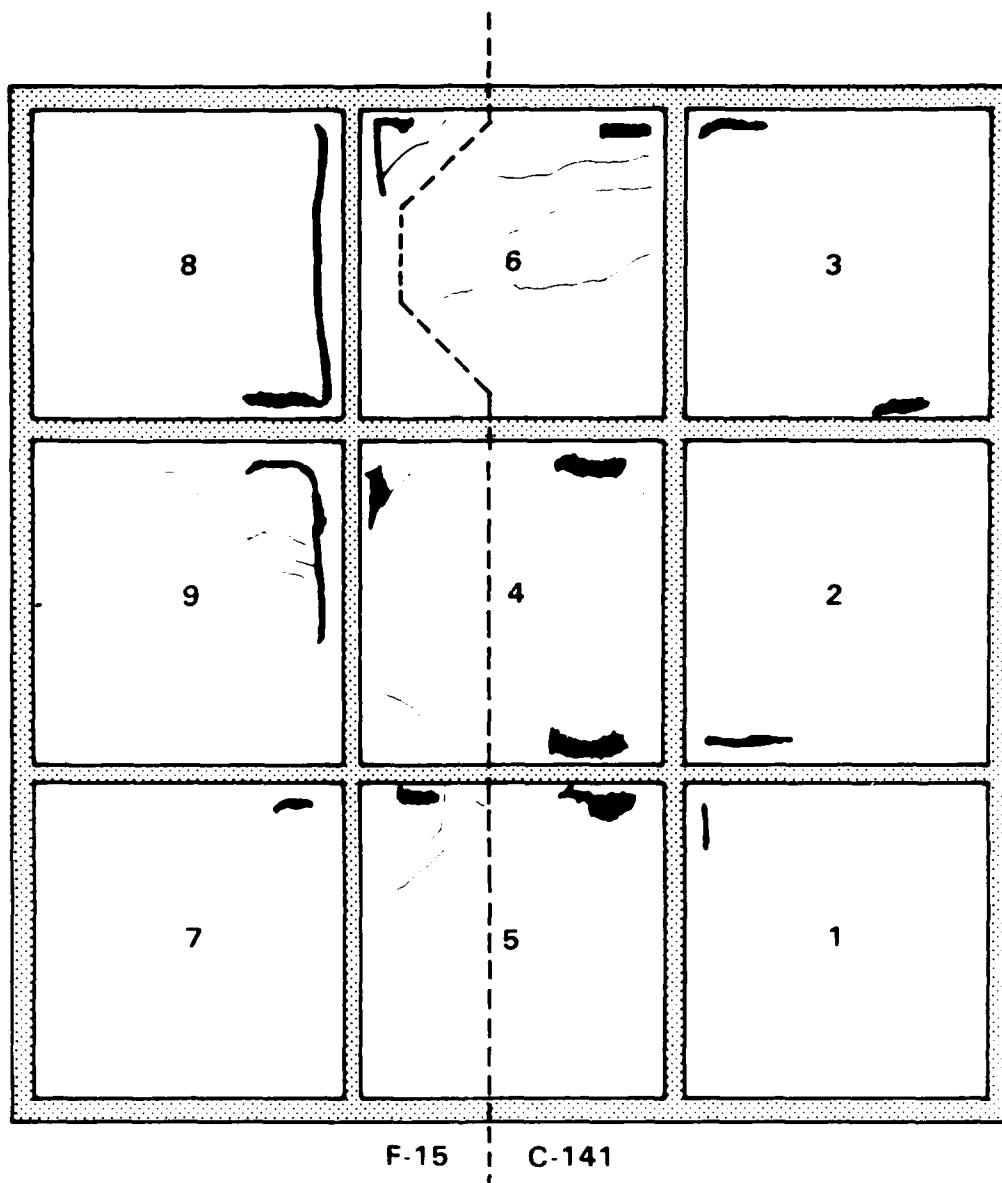
Figure 104. Damage to Slabs from F-15 and C-141 Traffic Loading, Normal Strength USAFE Slabs Test.

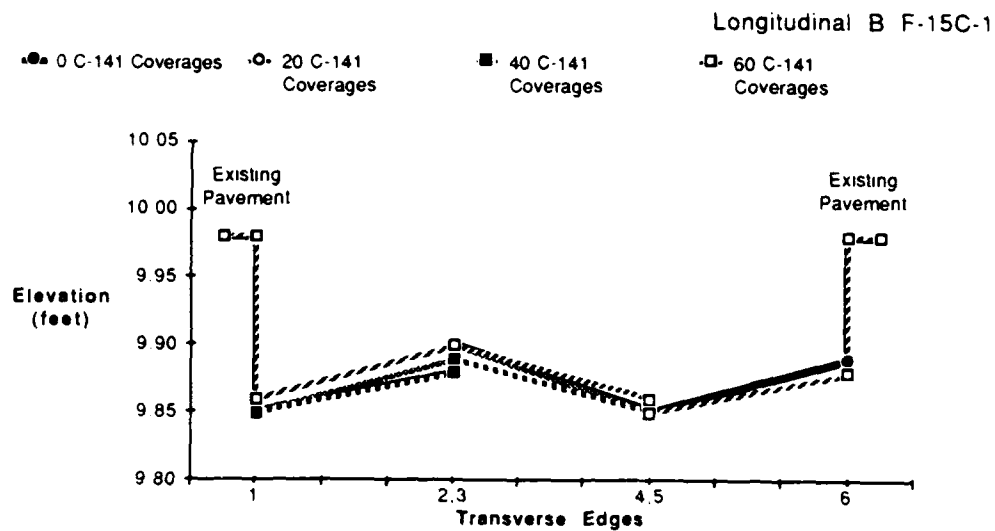
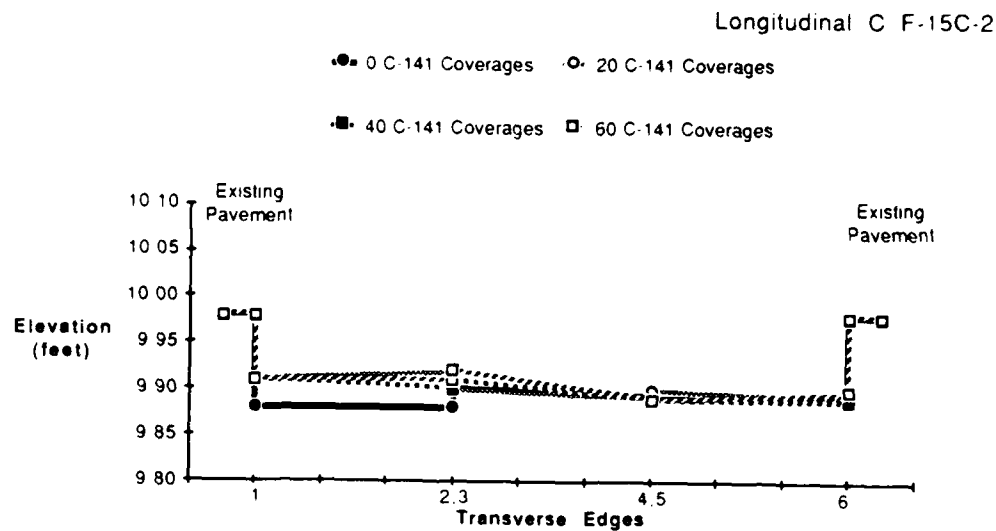
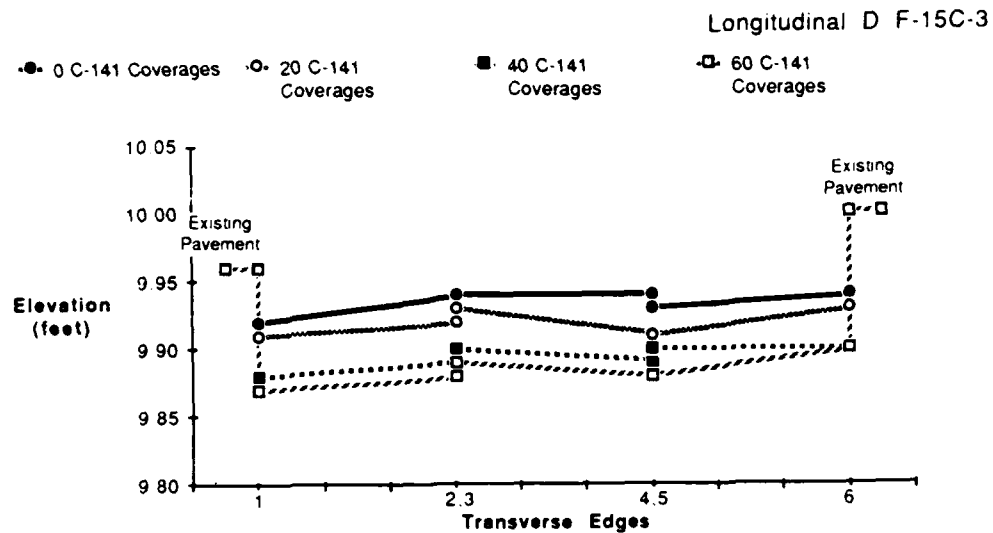
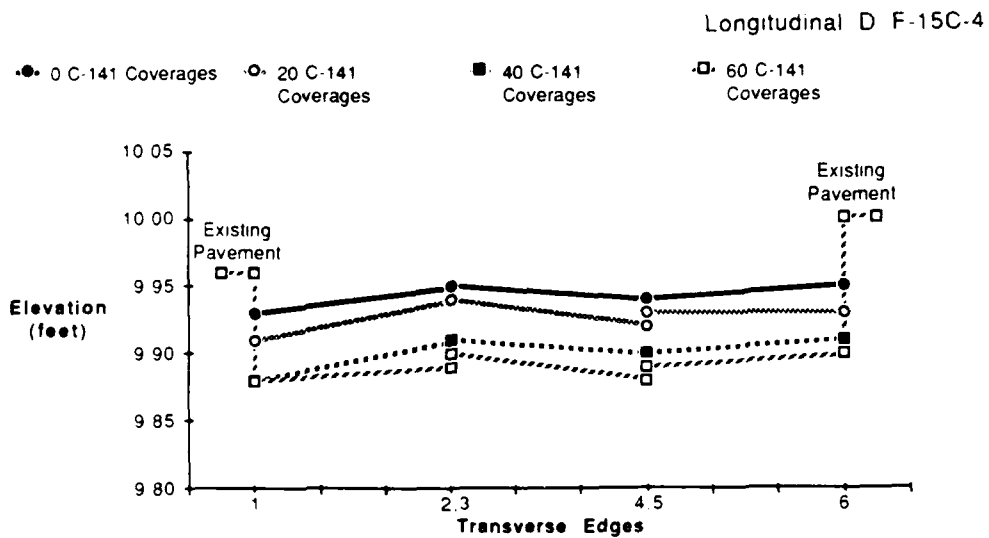
Traffic with the C-141 loadcart followed F-15 loadcart traffic. Elevation profiles are plotted in Figures 105 to 108. Personnel performed no maintenance repairs between F-15 and C-141 traffic. After 10 coverages, data collectors observed no additional damage to the concrete slabs and little tipping (1 inch maximum). They noted spalling in Slabs 2, 4, and 6 after 30 coverages (Figure 104), with the largest damage consisting of 10- by 4-inch spalls on both the east and west edges of Slab 4. These spalled areas enlarged after 60 coverages in Slabs 2, 4, and 6, and personnel noted new spalls in Slabs 1, 3, and 5. Slab 6 also developed three transverse cracks, and Slab 4 had a single crack 18 inches from the northwest corner. No repairs were required during C-141 traffic.

Figure 105. Slab Elevation Profiles Along Longitudinal Edge B, Normal Strength USAFE Slabs Test (0, 10, 40 and 70 C-141 Load-cart Coverages).

Figure 106. Slab Elevation Profiles Along Longitudinal Edge C, Normal Strength USAFE Slabs Test (0, 10, 40 and 70 C-141 Load-cart Coverages).

Figure 107. Slab Elevation Profiles Along Longitudinal Edge D, Normal Strength USAFE Slabs Test (0, 10, 40 and 70 C-141 Load-cart Coverages).

Figure 108. Slab Elevation Profiles Along Longitudinal Edge E, Normal Strength USAFE Slabs Test (0, 10, 40 and 70 C-141 Load-cart Coverages).

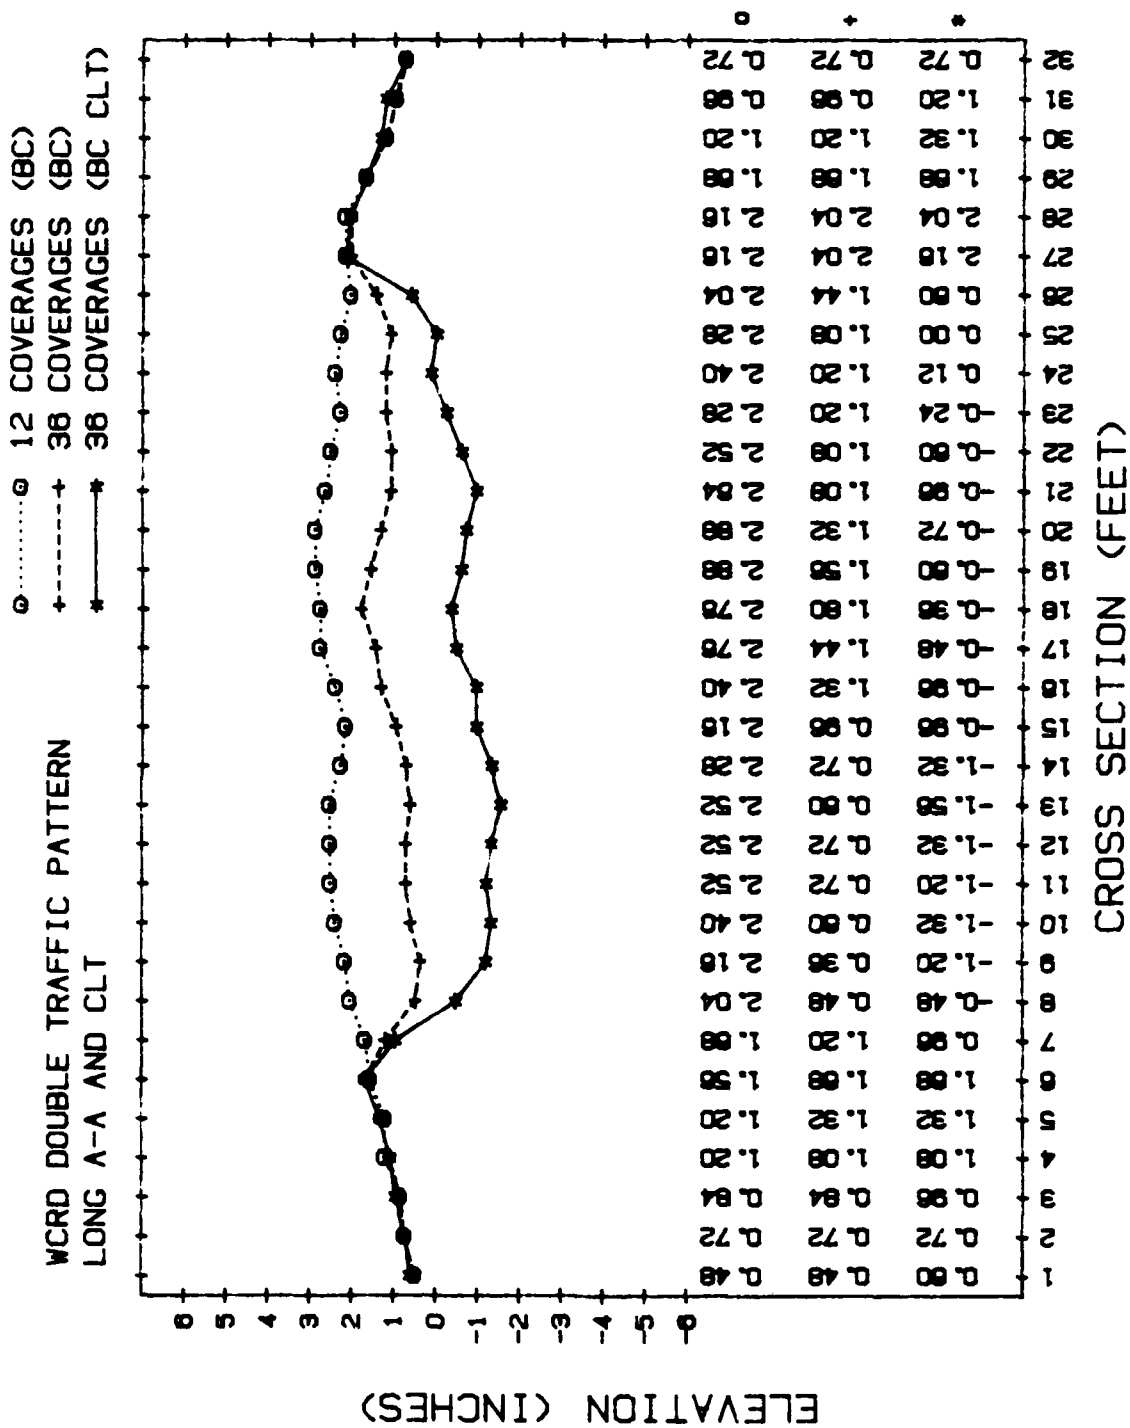
Figure 160. Base Course Elevation Profiles - Longitudinal A-A After
12 and 36 F-15 Loadcart Coverages (Second Pattern) and
Centerline of Traffic After 36 Coverages - For Wet Crater
Repair Demonstration.

Figures 160 and 161 show the longitudinal surface profiles, while Figure 162 shows the lateral surface profiles, after 12 and 36 F-15 loadcart coverages with the new pattern. Surface roughness measurements are not applicable and were not measured at the ramp (point 4, Figure 161). Also, elevation data were not recorded at points 28, 29, and 30 along longitudinal B-B after 12 loadcart coverages. When inputting data into the computer program used to plot the profiles and perform the surface roughness calculations, test analysts entered false elevations, consistent with the general profile shape, at these points (enclosed in squares) to preclude incorrect surface roughness calculations.
